**THE ARCHAEOLOGY AND SITE HISTORY  
OF  
75 STATE STREET**

**Michael Roberts**

**The Public Archaeology Laboratory, Inc.**

**January 9, 1989**

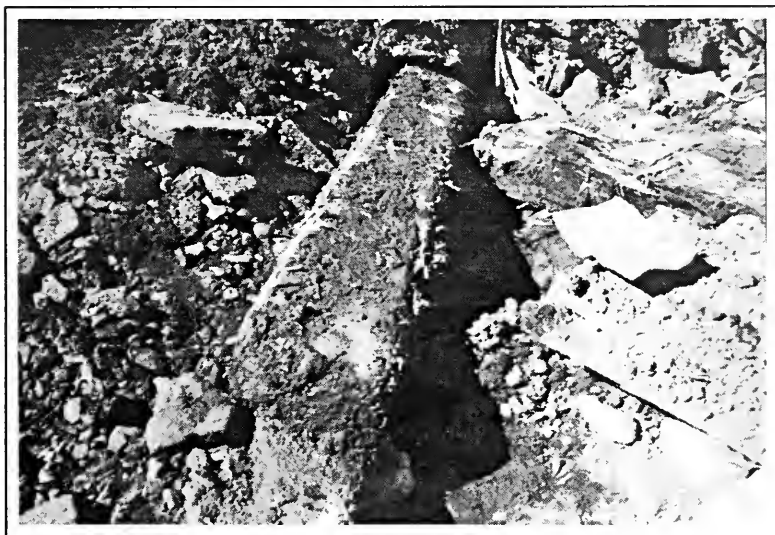
Photo 17 Squared timber with edge-halved scarfs and half lap.

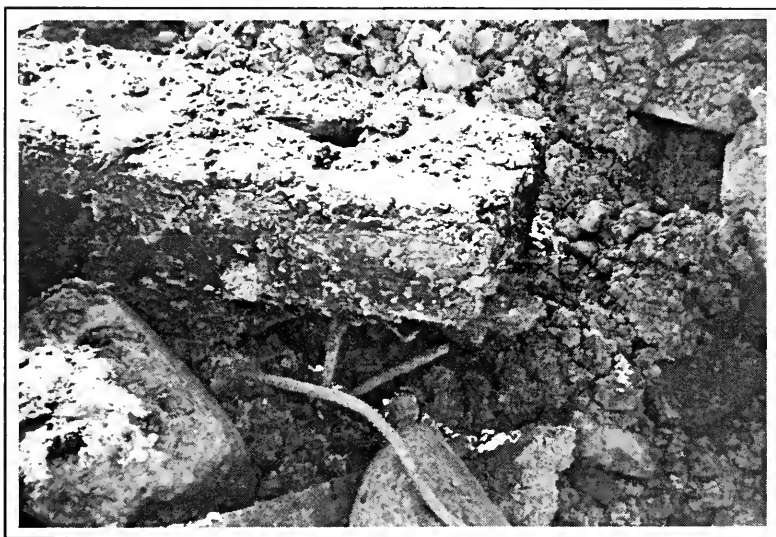
Photo 19 Edge-halved scarf with peg hole

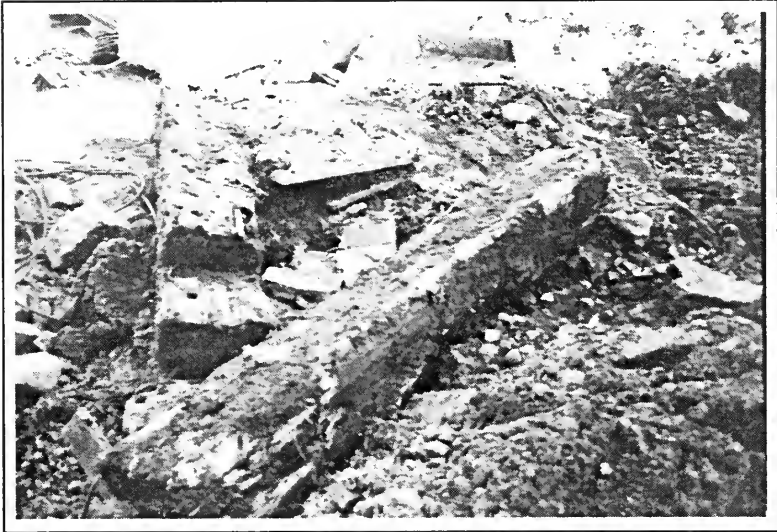
Photo 20 Edge-halved scarf one end; mortise at the other end
